## Worldwide repairs carried out with PolymerMetal®

REP-# 177

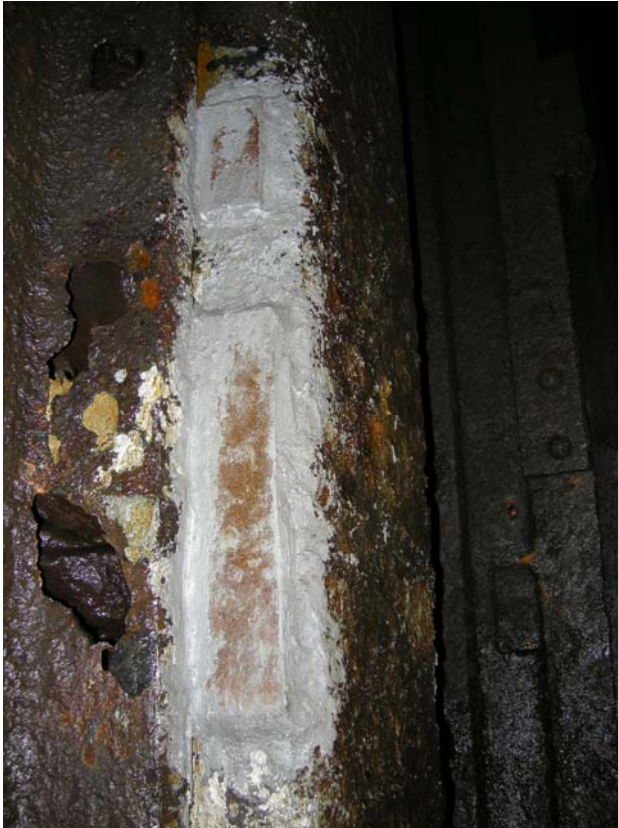
Damaged spot straight after coating with MM-metal UW

By way of trial some damaged spots at steel pilings were repaired with MM-metal UW. These areas showed perforation corrosion, so the surfaces were first cleaned and roughened. Then the PolymerMetal® was applied. At the same time steel sheets (wall thickness 10 mm) were prepared with MM-metal UW on the underside and attached to the damaged areas previously coated with this substance. Then further material was applied along the edges respectively in the border areas. Approximately one year later a visual test of the repair place was done. All fixed steel sheets are still in position, but partly they showed rust grains. Dissolutions are not to be recognised. On the contrary, after cleaning the areas treated with MM-metal UW look almost as new.

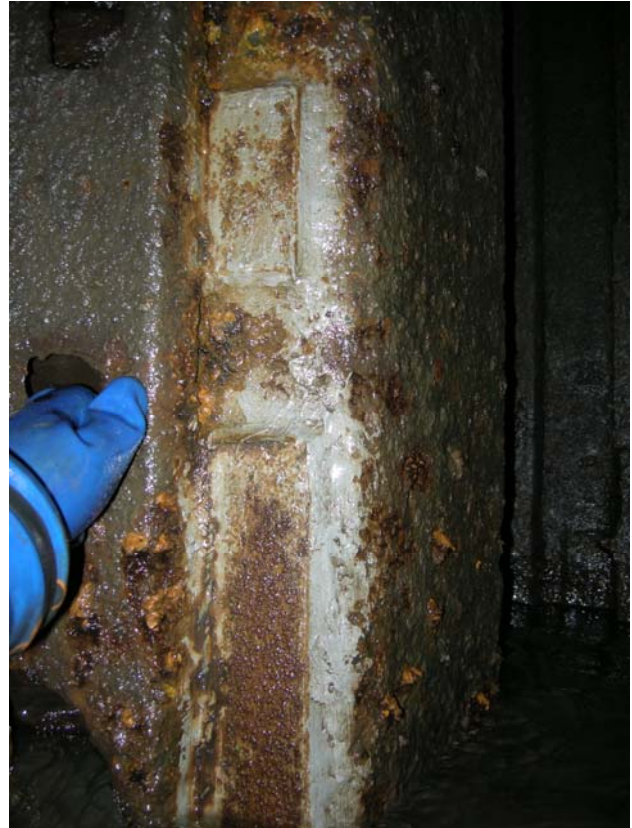
Damaged spot approx. one year later
