*Worldwide repairs carried out with PolymerMetal®*

REP-# 130

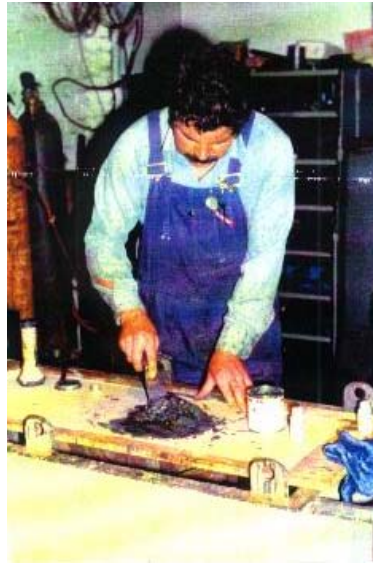
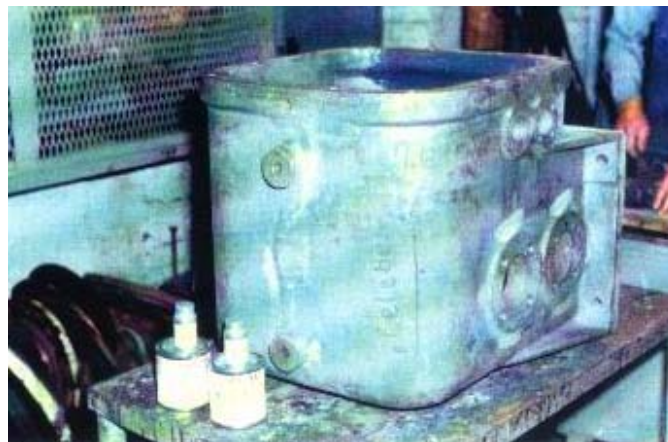
A cracked housing of a hydraulic pump in a steering gear made off aluminium was repaired using MM-metal SS-steelceramic with Hardener yellow. Afterwards the whole housing was coated with VP 10-017 in order to seal the pores in the casting.
