Worldwide repairs carried out with PolymerMetall®

REP-# 056

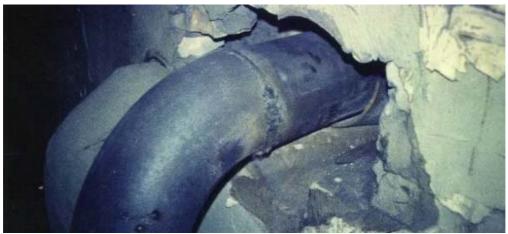
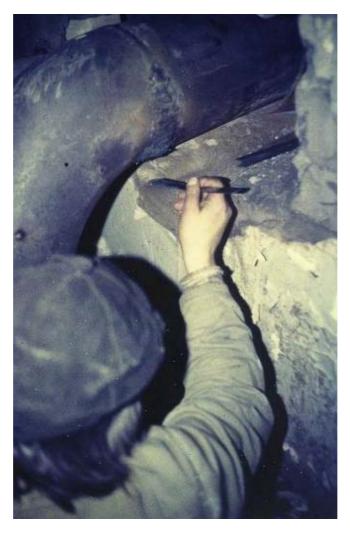
Sealing of a steam pipe under pressure by using MM-metal UW and Hardener UW3. Reason for the repair were cracks of welding seams caused by vibration at a working pressure of 2 bar and a temperature of 90 °C.
